**U.S. Coast Guard Research and Development Center**  
1082 Shennecossett Road, Groton, CT 06340-6096

**Report No. CG-D-08-00**

**EVALUATION OF WINDOW FAILURE MODES**

**FINAL REPORT  
DECEMBER 1999**

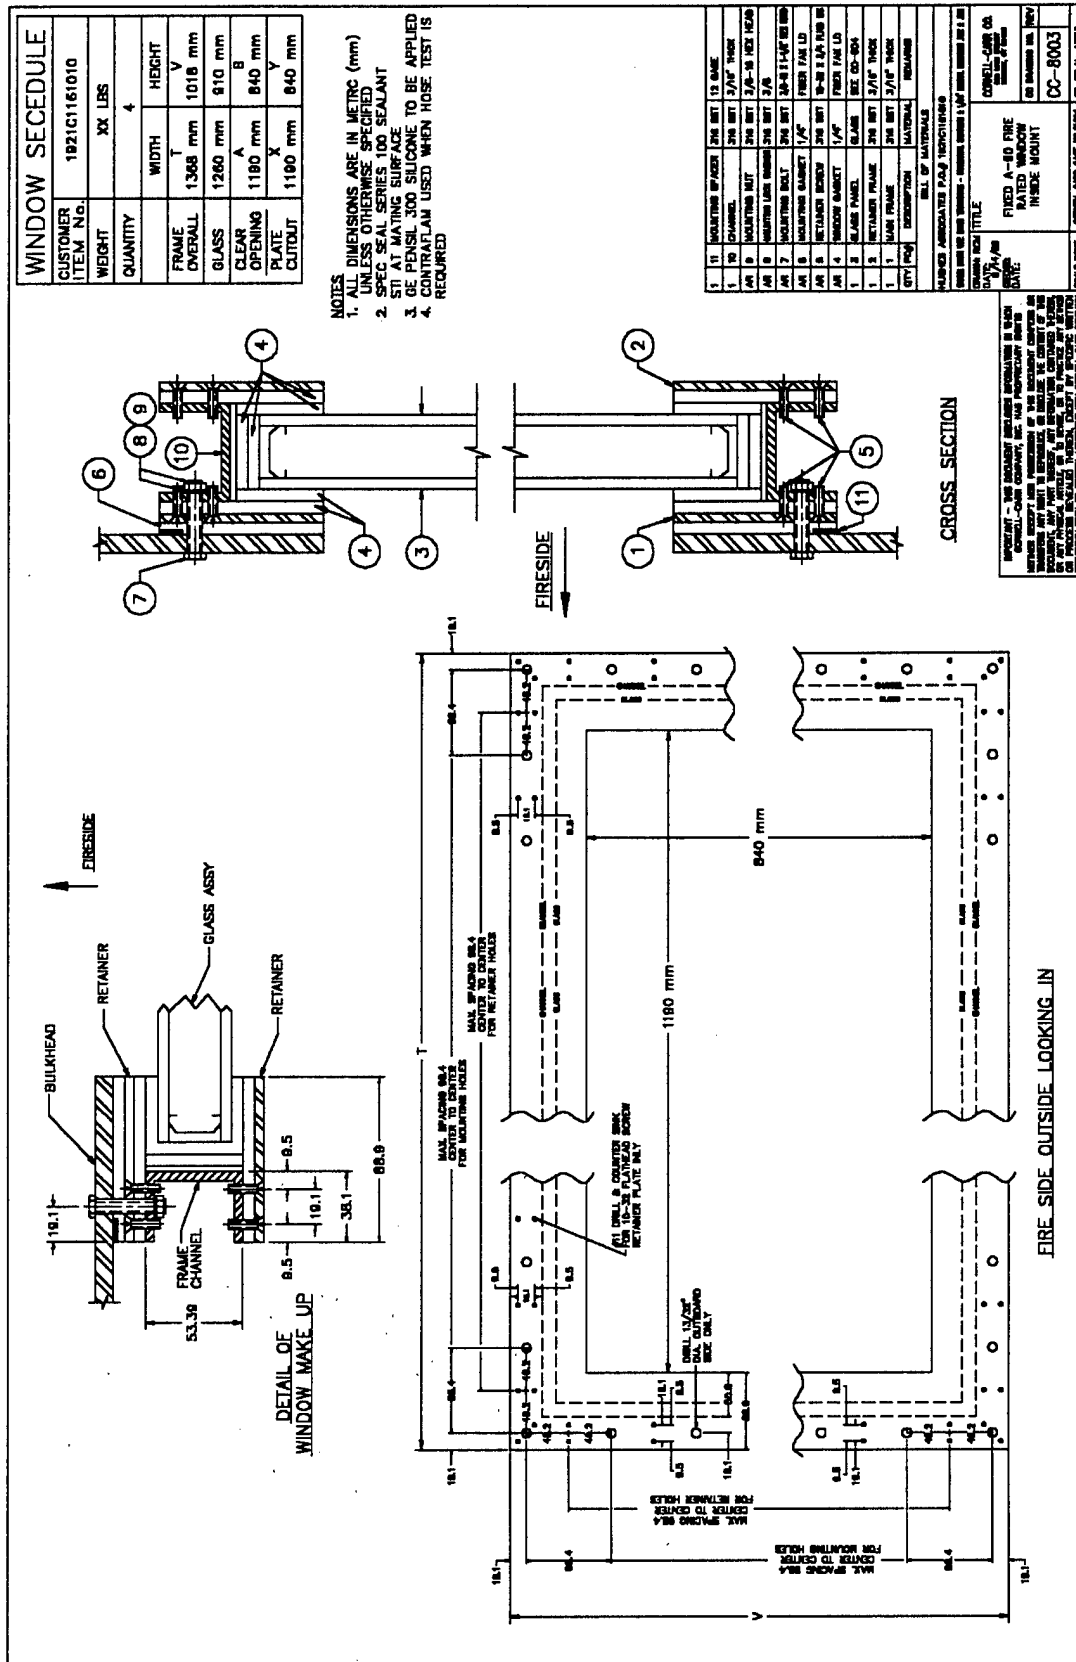
Figure 3. Drawings of the window assembly reproduced with permission of Cornell-Carr Company.

The window assemblies were supplied by Cornell-Carr Company, Inc., and their construction is detailed in figures 3 and 4. The glazing consisted of two panes of 6-mm thick tempered glass with a 28-mm thickness of Contraflam insulating gel sandwiched between the two layers of glass. The overall thickness of the glazing was 40 mm. Each pane was 1190 mm (46.85 in) high by 840 mm (33.07 in) wide.

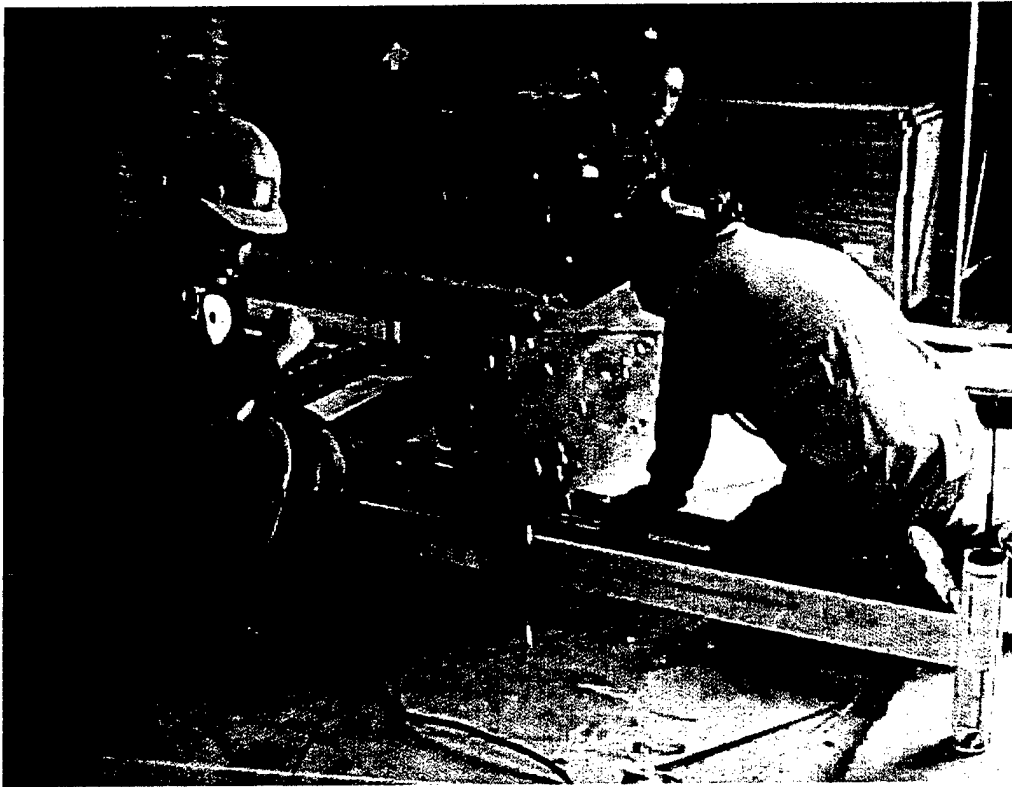
**Figure 5. Welding arrangement for damage.**

Prior to its installation in the bulkhead, one of the window assemblies was damaged using welding slag. This was accomplished with the window assembly in a horizontal position, and the arc welding (using a steel plate) above the top surface of the window assembly. This resulted in pitting of the tempered glass on the side to be exposed to the fire. figure 5 provides a photograph of the arrangement, and figure 6 provides a photograph of the damage. During the mounting of this window assembly, the damaged face of the window assembly completely fractured. figure 7 provides a photograph of the fractured glazing. It was deemed that this window assembly was not usable for further testing, and it was removed from the bulkhead.

A second window assembly was selected for damage. In this case, the window was initially mounted into the test frame prior to damage. Once the window was properly installed in the bulkhead, the arc welding technique used to damage the first window assembly was again used, but the welding was performed in the vertical orientation. Again, damage to the glazing was accomplished (see figure 8), but it appeared that the damage to the glazing did not penetrate the glass to the depth that was noted in the first window assembly. In this instance, the window assembly was damaged on the side not directly exposed to the fire (unexposed side).

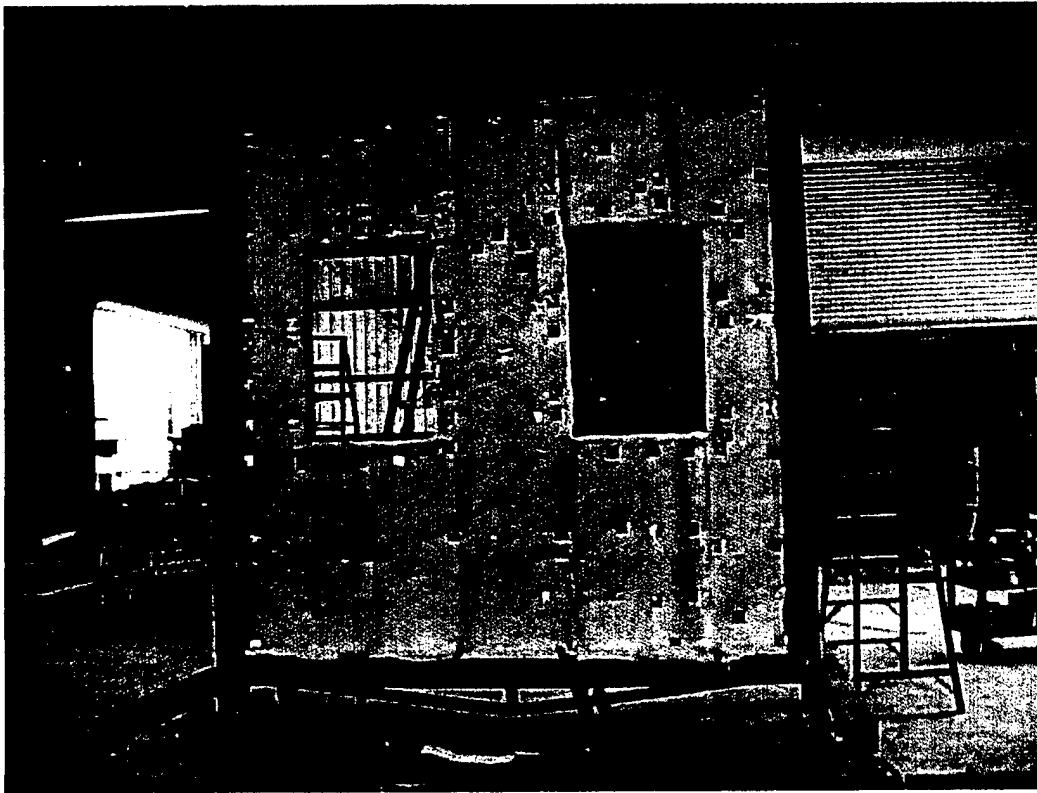
Figure 10. Photograph of exposed face – pre-test.

Figure 10 provides a photograph of the exposed face of the test assembly prior to test, and figure 11 provides a photograph of the test in progress. Figures 12 and 13 provide photographs of the unexposed face at 30 minutes into the test period and of the exposed face after the tests, respectively.
